BENNING ROAD & BRIDGES TRANSPORTATION IMPROVEMENTS

CRASH DATA AND SAFETY ANALYSIS TECHNICAL MEMORANDUM

FINAL SEPTEMBER 2020

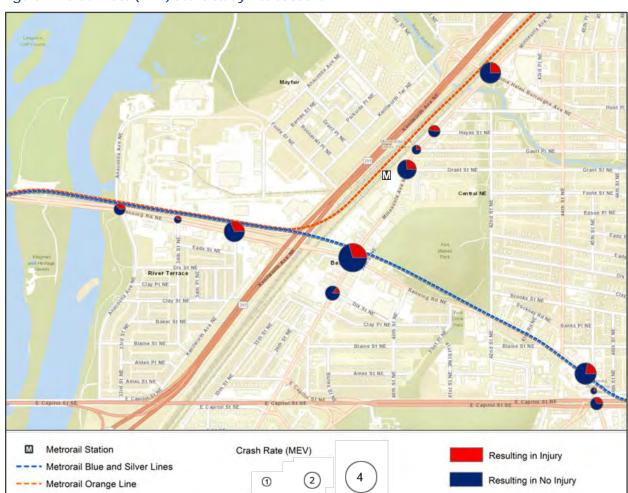
Figure 1: Crash Rate (MEV) at the Study Intersections

The summary of crash rate at the study intersections is provided in **Figure 1**. **Table 1** provides detailed statistics about crash data.

- Just over half (seven) of the 12 key crash intersections in the study area are located along Benning Road, which is the project corridor for the two build alternatives;
- The highest crash rate location is at Benning Road and Minnesota Avenue with an MEV of 4.17;
- The second highest crash rate location is at Benning Road and 45th Street with an MEV of 2.41:
- The third highest crash rate location is at Minnesota Avenue and Nannie Helen Burroughs Avenue with an MEV of 2.27; and
- The annual average for the number of crashes for the 12 key intersections from 2016 to 2018 was 203, while the annual average for crashes resulting in injury was 58.

Principal observations from **Figure 1** and **Table 1** include:

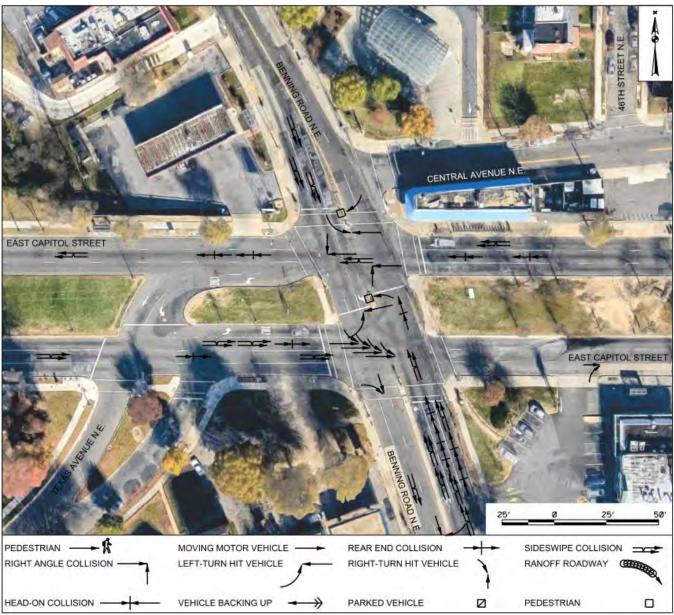
Figure 3: Benning Road and East Capitol Street Crash Diagram

The Distribution of crashes for the Benning Road and East Capitol Street intersection is shown in **Figure 3**. After analysis by DDOT, a list of factors contributing to the crashes was compiled and is provided in **Table 4**.

Movement	Collision Type	Potential Causes of Crashes				
	Sideswiped	 Inadequate storage space for northbound left turn traffic Heavy left turn volume in the morning peak-period (450 vehicles) Split phasing, which may cause lane changes during queue clearance 				
Northbound Benning Road	Rear-End	 Stop and go traffic due to peak-period congestion Speeding and more aggressive behavior due to cycle overflows (i.e., queue cannot clear the intersection in the current cycle) 				
	Left Turn Hit Vehicles	Short left turn laneSignal Timing				
Eastbound East Capitol Street	Rear-End	 Stop and go traffic due to peak-period congestion Speeding and more aggressive behavior due to cycle overflows (i.e., queue cannot clear the intersection in the current cycle)

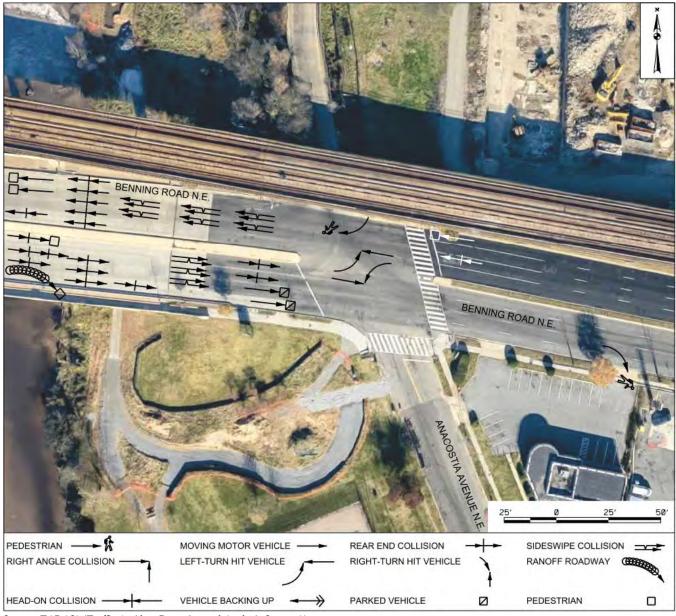
Figure 6: Benning Road and Anacostia Avenue Crash Diagram

Figure 6 provides crash analysis information for the Benning Road and Anacostia Avenue intersection. This intersection in not classified as a high crash frequency location.

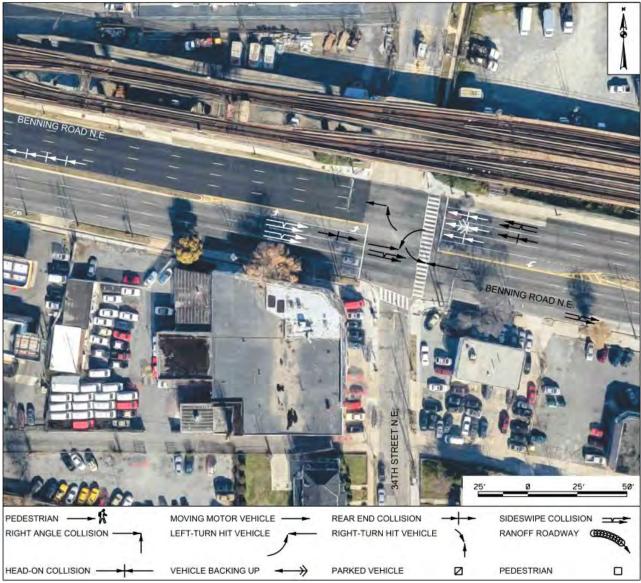
Figure 7: Benning Road and 34th Street Crash Diagram

Figure 7 provides crash analysis information for the Benning Road and 34th Street intersection. This intersection in not classified as a high crash frequency location.

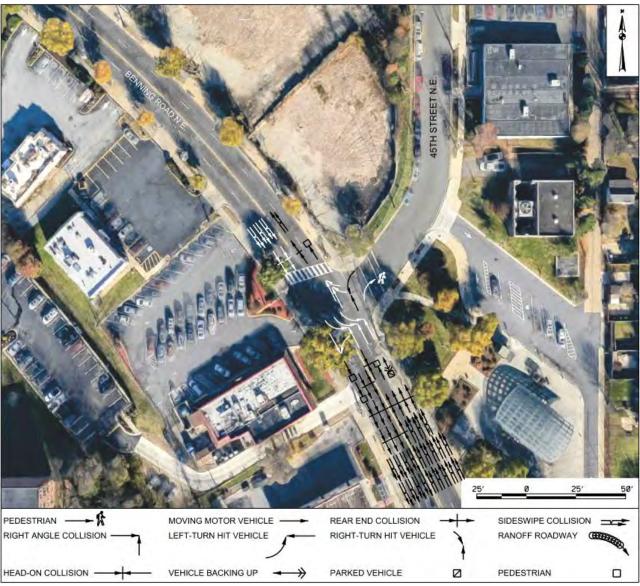
Figure 8: Benning Road and 45th Street Crash Diagram

Figure 8 provides crash analysis information for the Benning Road and 45th Street intersection. This intersection in not classified as a high crash frequency location.

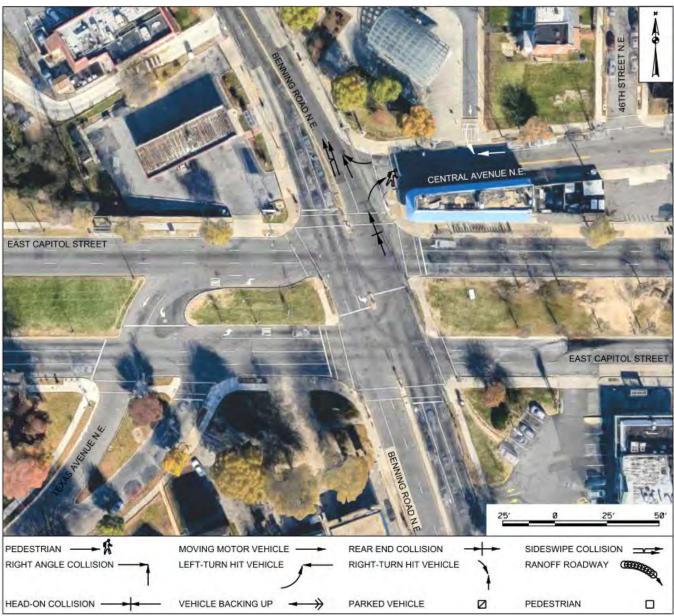
Figure 9: Benning Road and Central Avenue Crash Diagram

Figure 9 provides crash analysis information for the Benning Road and Central Avenue intersection. This intersection in not classified as a high crash frequency location.

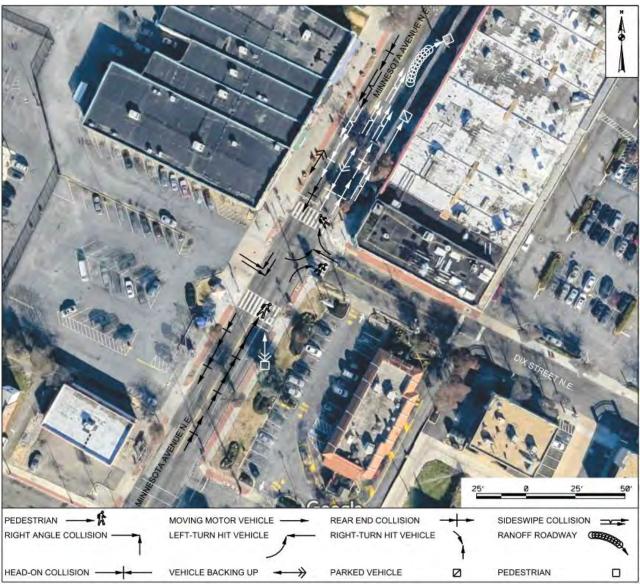
Figure 10: Minnesota Avenue and Dix Street Crash Diagram

Figure 10 provides crash analysis information for the Minnesota Avenue and Dix Street intersection. This intersection in not classified as a high crash frequency location.

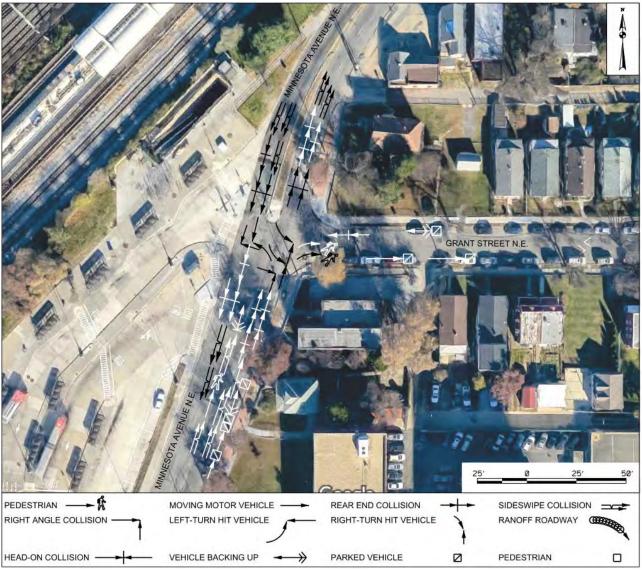
Figure 11: Minnesota Avenue and Grant Street Crash Diagram

Figure 11 provides crash analysis information for the Minnesota Avenue and Grant Street intersection. This intersection in not classified as a high crash frequency location.

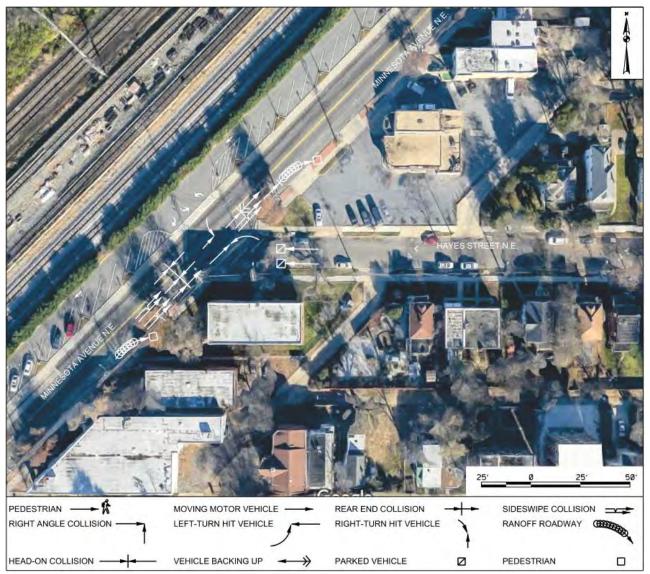
Figure 12: Minnesota Avenue and Hayes Street Crash Diagram

Figure 12 provides crash analysis information for the Minnesota Avenue and Hayes Street intersection. This intersection in not classified as a high crash frequency location.

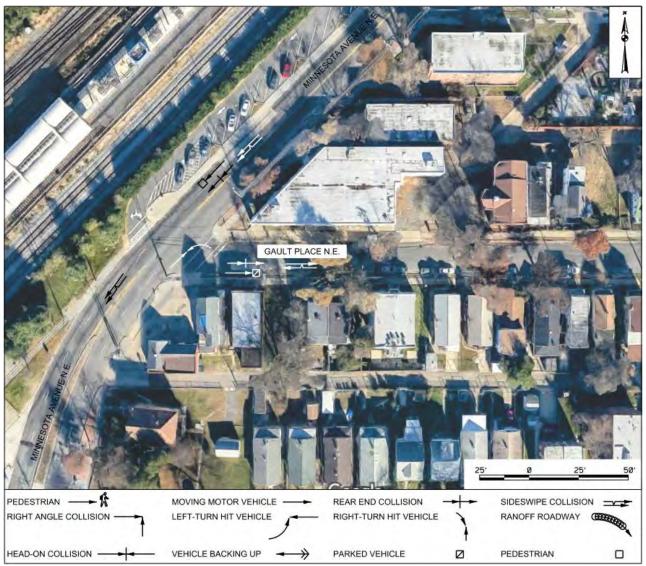
Figure 13: Minnesota Avenue and Gault Place Crash Diagram

Figure 13 provides crash analysis information for the Minnesota Avenue and Gault Place intersection. This intersection in not classified as a high crash frequency location.
